# Board Level Failure Analysis of Chip Scale Package Drop Test Assemblies

Nicholas Vickers, Kyle Rauen, Andrew Farris, Jianbiao Pan  
Cal Poly State University  
San Luis Obispo, CA 93407

## Abstract

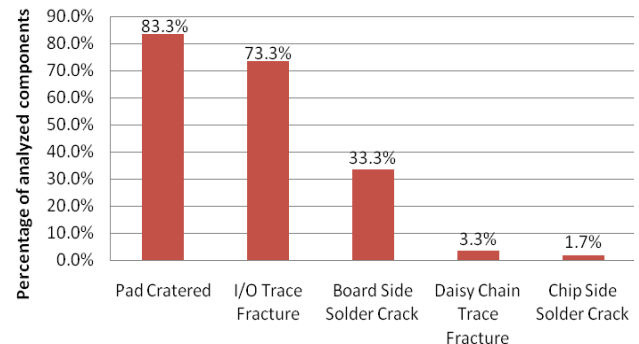
Figure 2. Summary of failure modes

After analyzing 60 components on four boards that were dye penetrated, five failure modes have been identified: 1) pad cratering, 2) solder cracking near the board side, 3) solder cracking near the component side, 4) input/output (I/O) trace fracture, and 5) daisy chain trace fracture. Figure 2

summarizes the percentage of each failure mode on these 60 components analyzed. It shows that pad cratering is the dominant failure mode for these test vehicles in drop impact; 83.3% of the components exhibited pad cratering. Pad cratering is defined as cracking in the thin resin rich region underneath the copper pads and traces as shown in Figure 3. Note that some components had multiple failure modes so that the total percentage shown in Figure 2 is more than 100%.

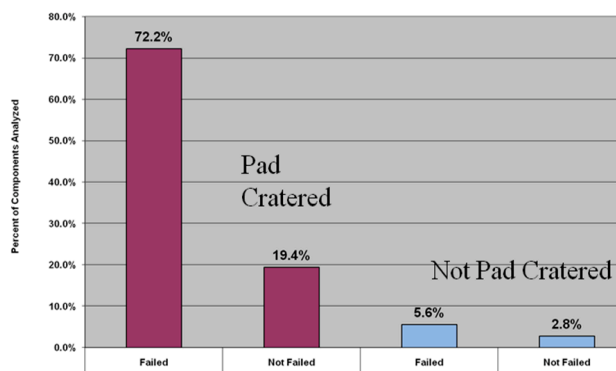
Figure 8. The relationship observed between pad cratering and electrical failure

It should be pointed out that pad cratering does not necessarily lead to electrical failure of solder joints. Figure 8 shows the relationship between pad cratering and electrical failure. It shows that 19.4% of components that had pad cratering did not fail electrically. The figure also indicates that most components that electrically failed exhibit pad cratering, but pad cratering occurred on some components that were not yet failed; pad cratering

was observed in combination with other failure modes.

implying that daisy chain trace fracture is caused by pad cratering. Conversely, solder cracking appears to be independent of pad cratering. This is shown by Figure 8 where 5.6% of electrical failures are caused by solder cracking where pad cratering was not observed. Cracking of the solder joints on the board side and component side was observed in 33.3% and 1.3% of the components, respectively.

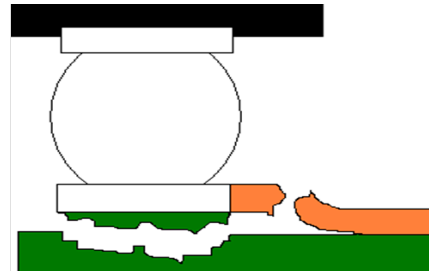
Figure 10. Illustration of cracked trace caused by pad cratering

Combining the failure analysis with the reliability study previously reported [11], we see that pad cratering indirectly causes electrical failure. The reasons for this are simple, when the resin cracks under the solder joint, stress is then shifted on to the electrical trace on the PCB. When this occurs the trace can fracture as illustrated in Figure 10. These trace fractures occur both at outside trace connections where the input and output signals occur, and also in traces that connect solder balls within the BGA.

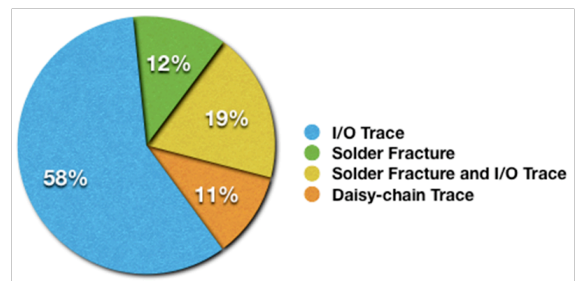
Figure 11. Percentage of electrical failure attributed to the different material failure modes

Figure 11 compares the ratios of failure modes. Input/output trace failures were attributed to causing 77% of the electrical failures. Of that 77%, 19% were in conjunction with solder fracture. Solder fracture accounts for 12% of the electrical failures observed, and 11% of the electrical failures were caused by the daisy chain trace fracturing.

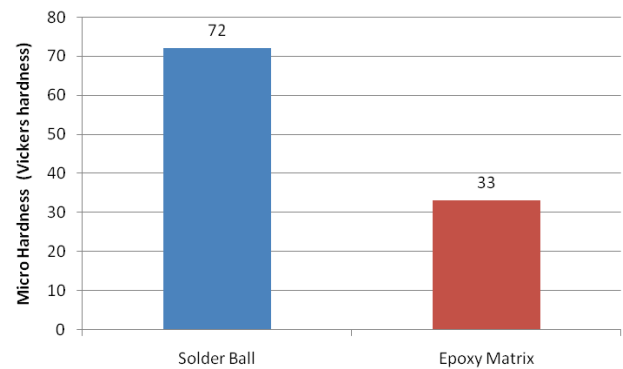
Figure 15. Results of the microhardness testing

After evaluating the cross-sectioned samples, an investigation of the solder ball microstructure and also the relative strength of the solder material compared to the resin was performed. The resulting microstructure of the solder ball as shown in Figures 14a and 14b shows small dendritic grain growth. The smaller grains strengthen the solder material. Failures are consequently shifted to the weaker material, the resin. Figure 15 shows the microhardness test results. The solder material had an average microhardness of 72 while the resin has a microhardness of 33. The result indicates that the solder is much stronger than the resin. This finding verifies that the resin is the weakest link and suggests that pad cratering should be the most common material failure.
